A Case Study of Successful Performance of Retrofitted Masonry Substations

Noor Aina Misnon¹, Dmytro Dizhur¹, John Mackenzie², Rijalul Fikri¹, Shannon Abeling¹ and Jason Ingham¹

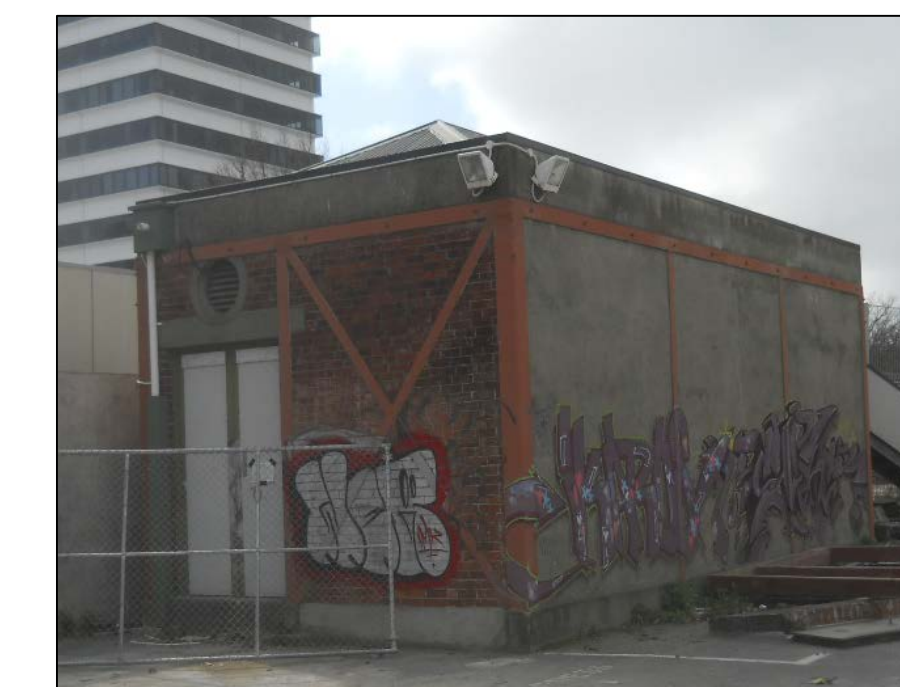
Diagonal and vertical steel bracing members

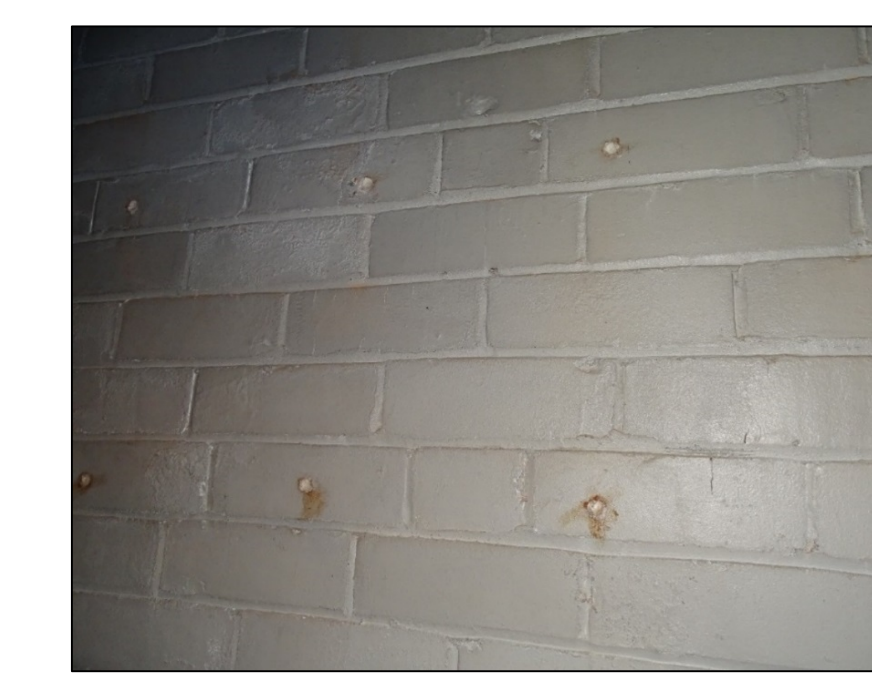
Epoxied steel dowels

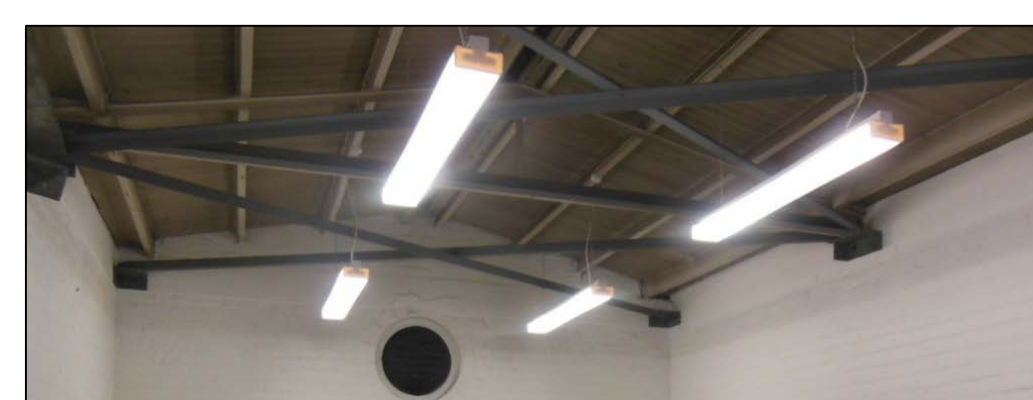
Steel bracing of roof diaphragm

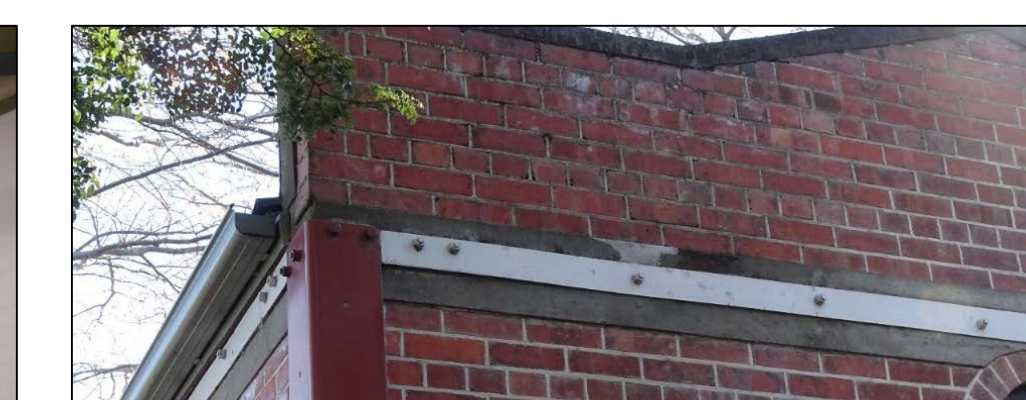
Installed steel plate on perimeter beam at eaves level

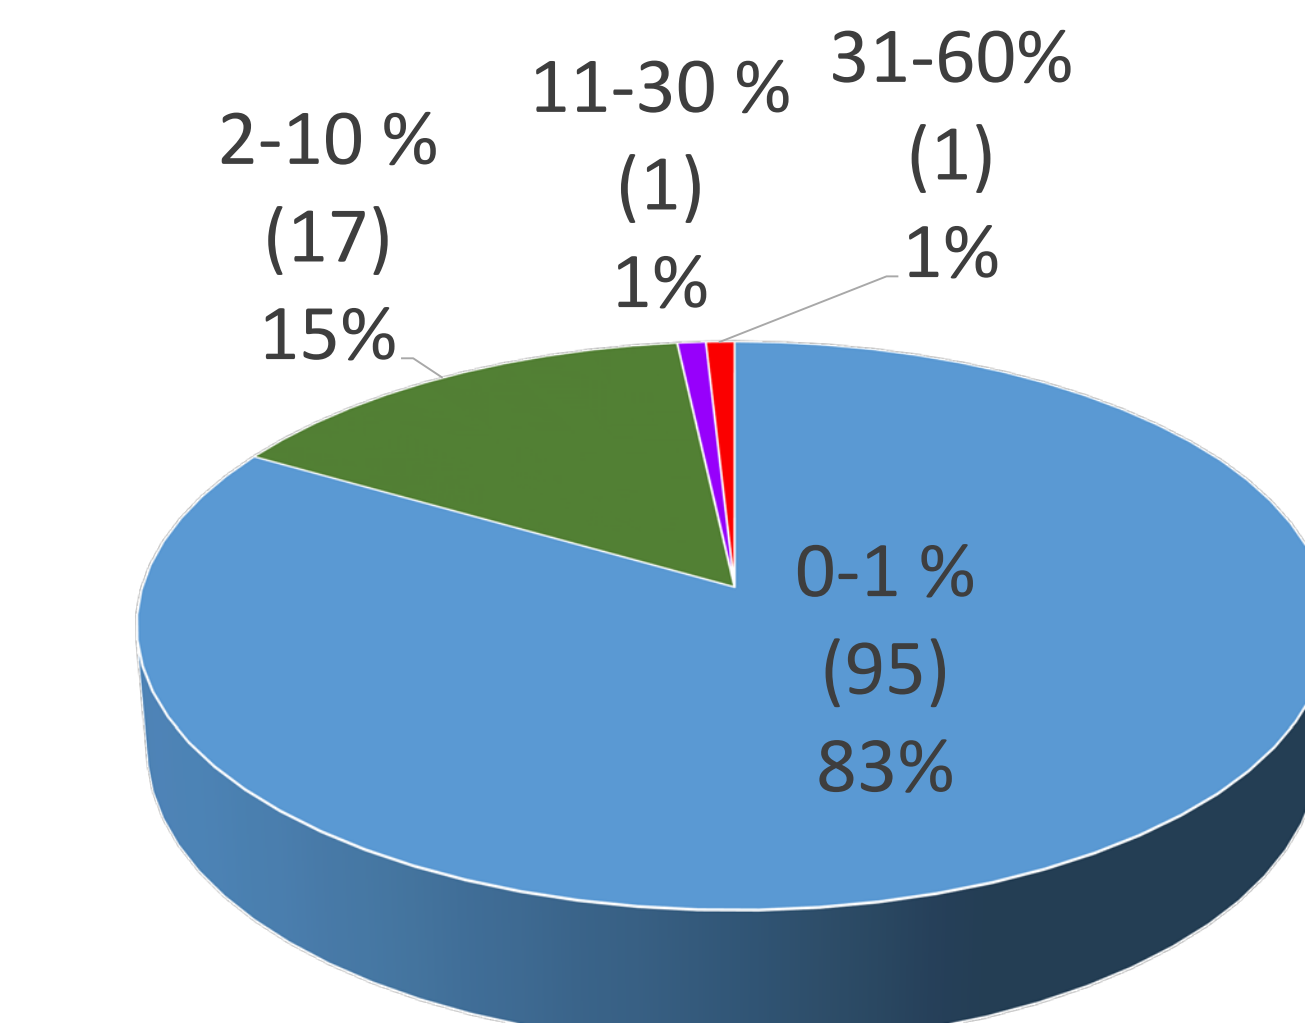
Fig. 6. Building damage levels

Overall building damage

■ 0-1 % ■ 2-10 % ■ 11-30 % ■ 31-60 %

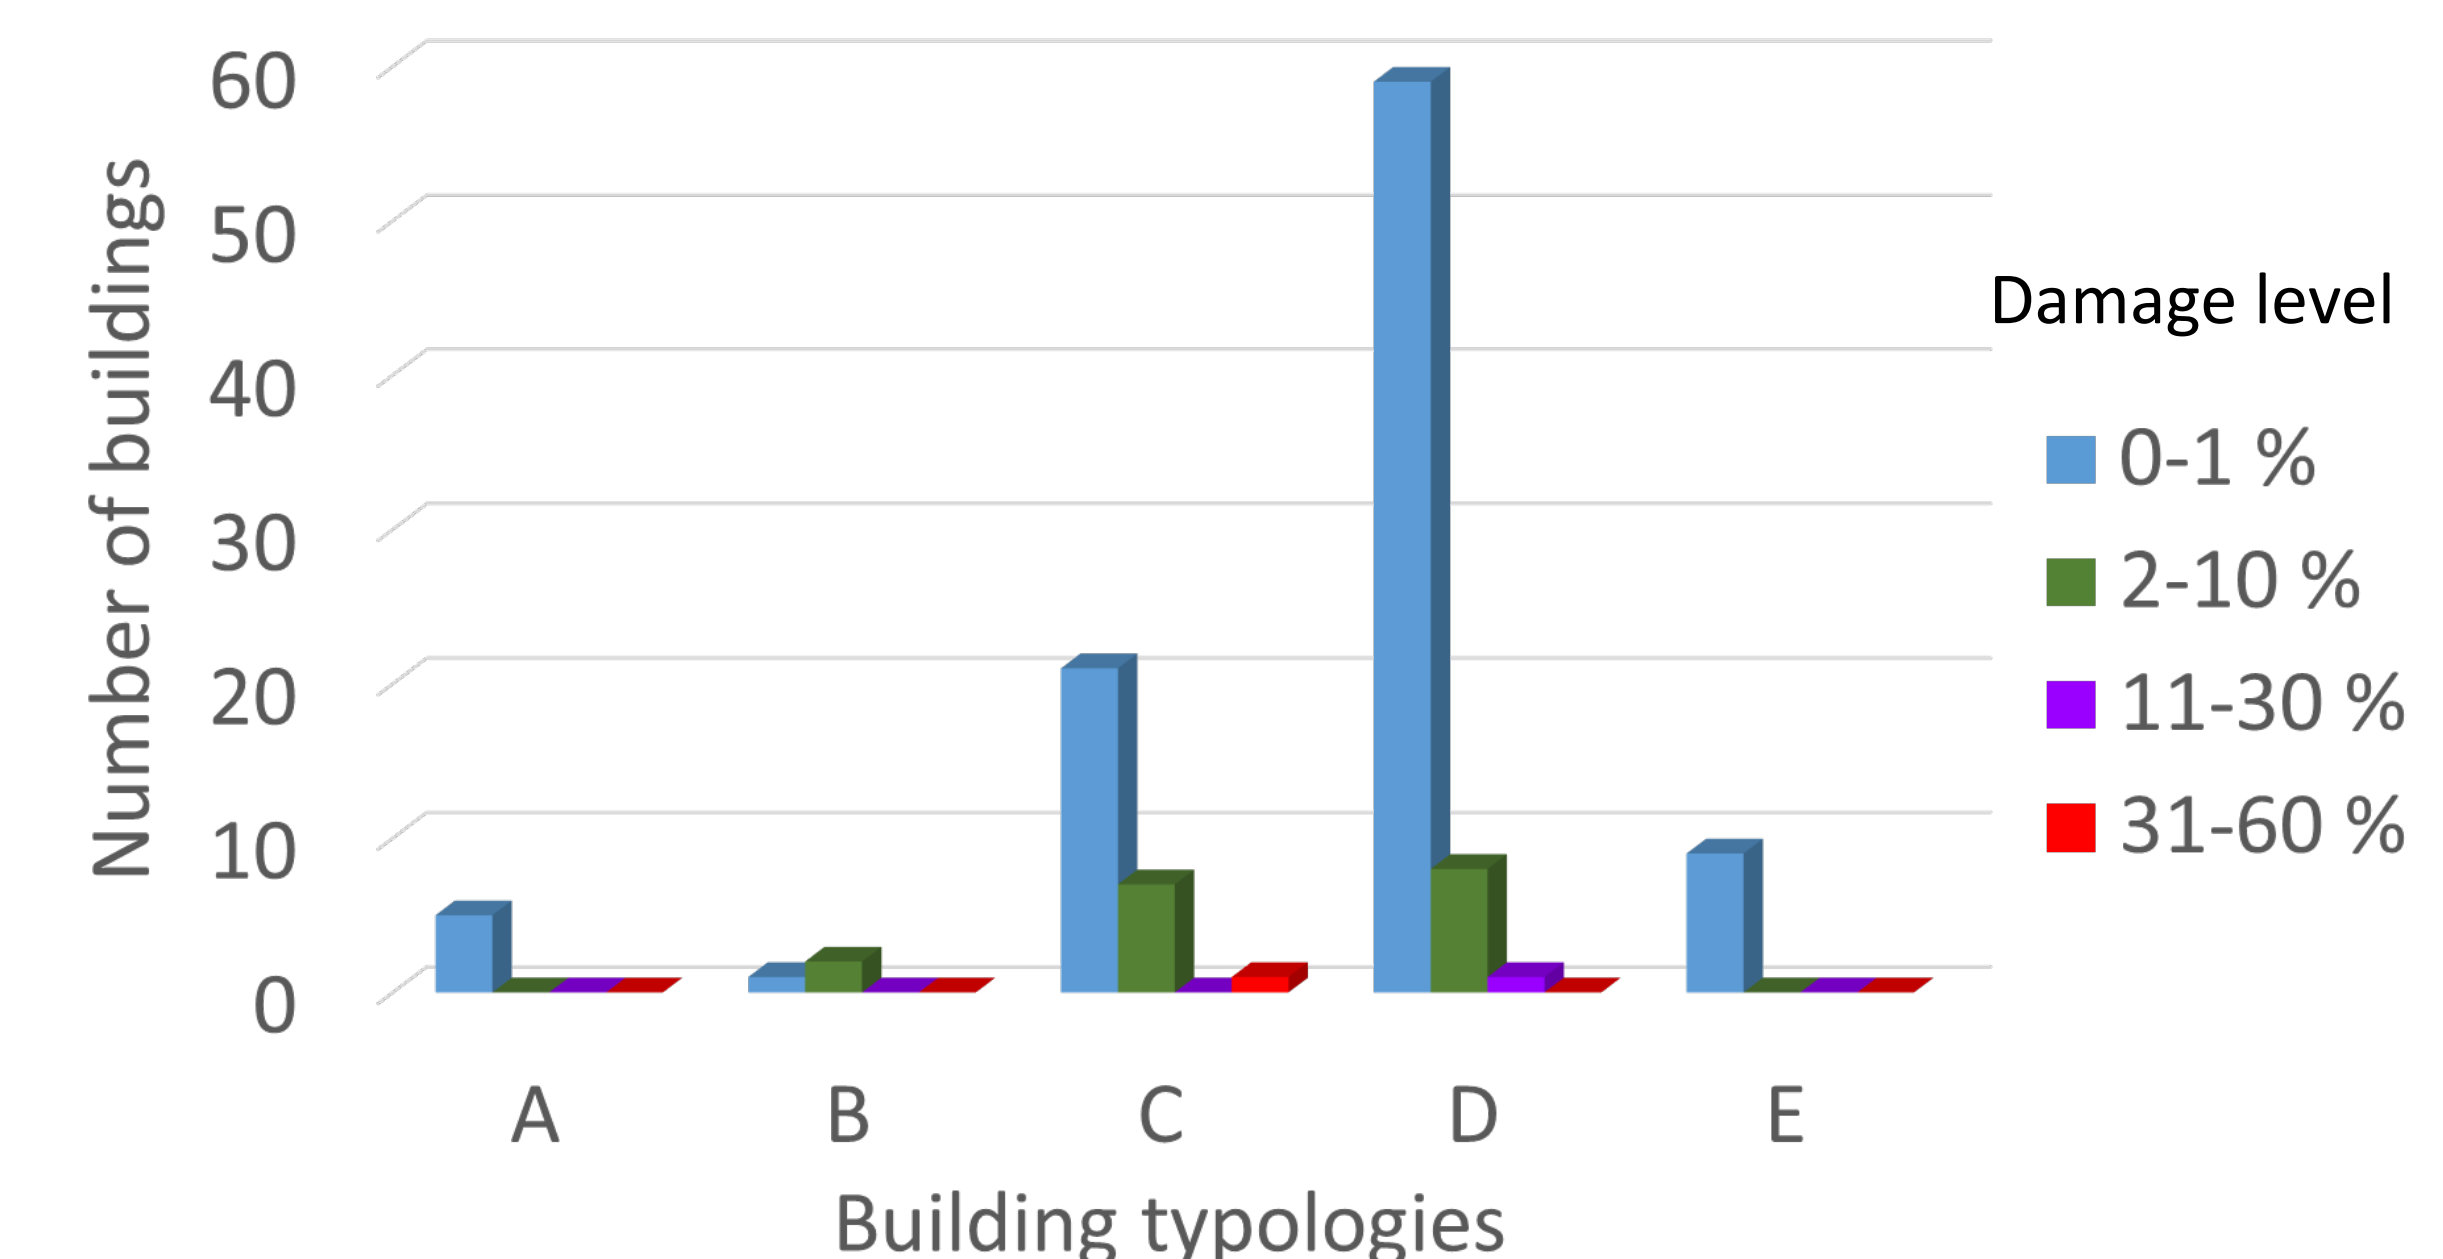
Fig. 7. Distribution of damage levels

- 83% of the substation buildings survived with minor damage and 15% survived with moderate damage while only two substation buildings experienced significant and heavy damage.
- Cost savings were approximately up to \$NZD70 million.
- Because many historical buildings were demolished after the 2010/2011 Canterbury earthquakes, these substations have increased heritage importance within the community.
